## MEMORANDUM

**DATE:** OCTOBER 24, 2014  
**TO:** SHERRY GLASS, TDWR  
**CC:** CHAD AUGUSTIN, TDWR  
**FROM:** JOHN HOFFELT, PG  
**RE:** EXCESSIVE SEDIMENT DISCHARGE NORTH FORK MILL CREEK

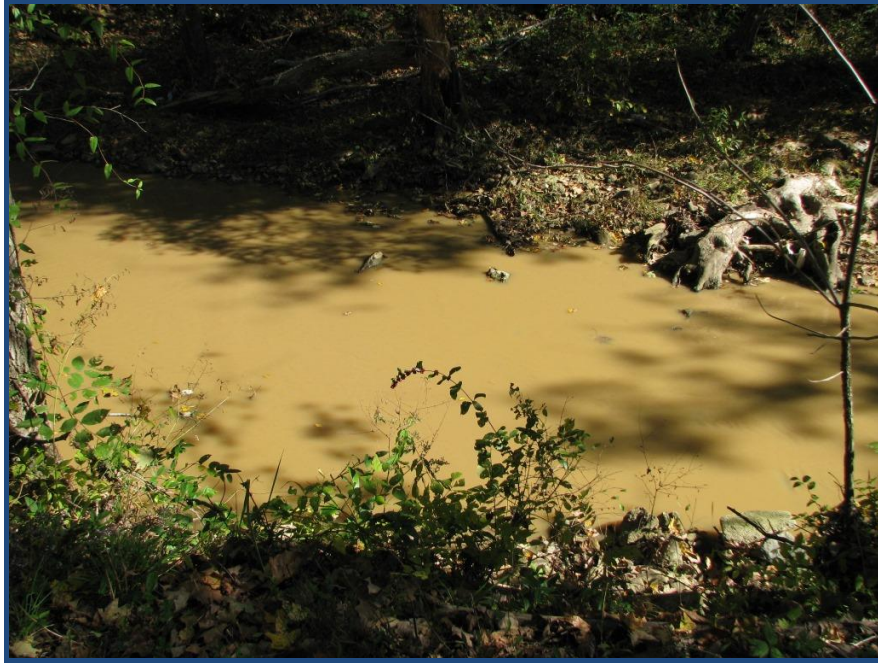
Photo 1      Site: North Fork Mill Creek      Date: October 21, 2014  
Time: 1422 hrs      Direction: Southeast      Personnel: John Hoffelt, TDOR; Candice Teichert, US  
EPA      Description: Condition of North Fork Mill Creek at location 35.89085 -087.36672,  
showing excessive turbidity.

Photo 1 shows the condition of North Fork Mill Creek where we first observed the muddy condition, about 1.1 miles downstream from the NPDES discharge point. At the next point that Oak Hill Road is next to the creek, we observed turbid water flowing from the Unnamed Tributary on the east side of the road. Water in North Fork Mill Creek above this confluence was clear. Photos 2, 3, 4, and 5 were taken at this location, showing the effects of the turbid inflow. We were able to view the Unnamed Tributary in two locations as we ascended the hill on Wrigley Road, as shown in Photos 6 and 7. We followed the flow to its origin at the Bon Aqua-Lyles Utility District outfall, as shown in Photo 8. Photo 9 shows the identifying sign at the outfall.

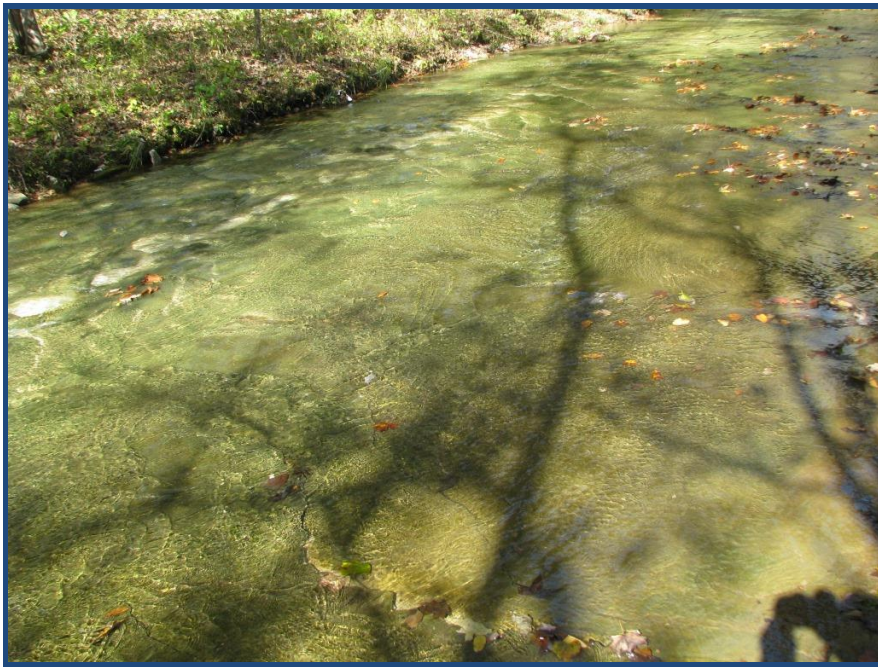
Photo 2      Site: North Fork Mill Creek      Date: October 21, 2014  
Time: 1424 hrs      Direction: Northeast      Personnel: John Hoffelt, TDOR; Candice Teichert, US  
EPA      Description: Condition of North Fork Mill Creek at location 35.89638 -087.36358,  
showing clear water conditions upstream of the unnamed tributary discharge.

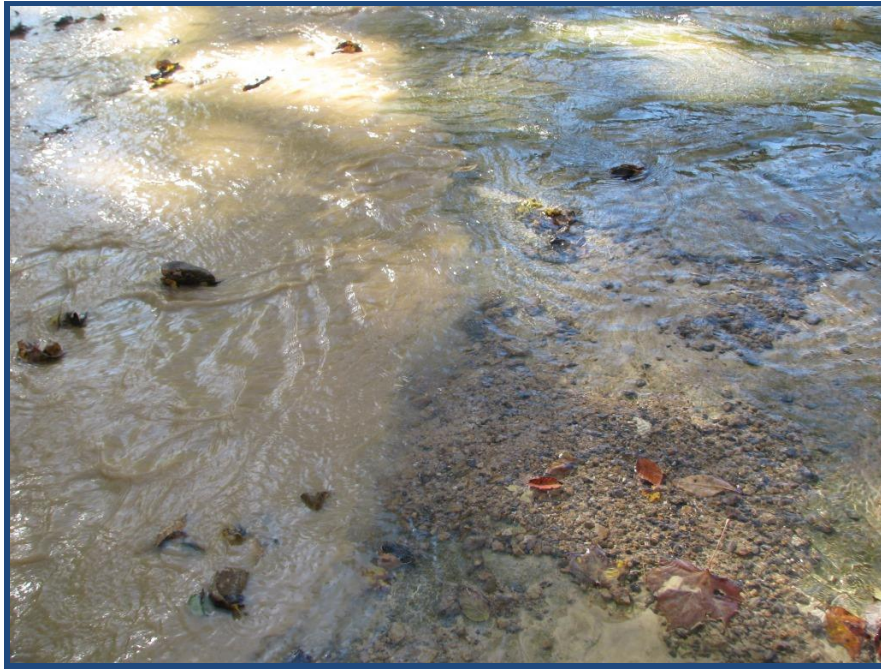
Photo 3      Site: North Fork Mill Creek      Date: October 21, 2014  
 Time: 1425 hrs      Direction: Southwest      Personnel: John Hoffelt, TDOR; Candice  
 Teichert, US EPA      Description: Confluence of North Fork Mill Creek and Unnamed  
 Tributary discharge at location 35.89638 -087.36358, showing clear water of North Fork Mill Creek on  
 right and turbid water from Unnamed Tributary on left.

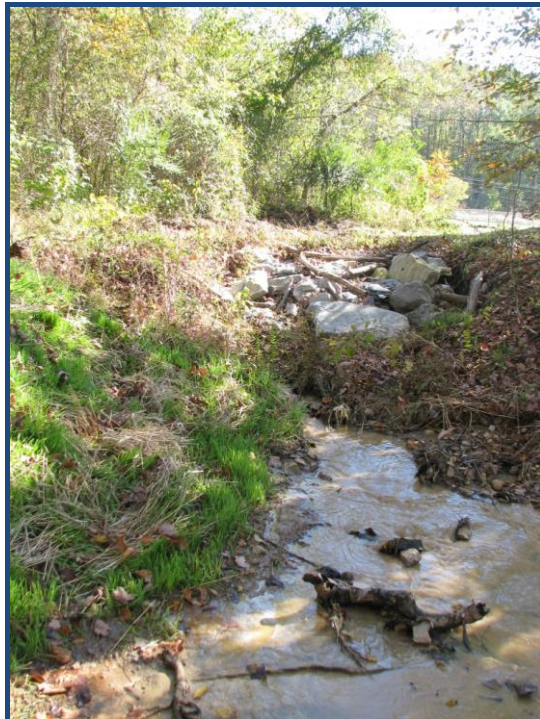
Photo 4      Site: North Fork Mill Creek      Date: October 21, 2014

Time: 1425 hrs      Direction: Southeast      Personnel: John Hoffelt, TDOR; Candice Teichert, US EPA  
Description: Culvert discharge into North Fork Mill Creek from Unnamed Tributary at location 35.89638 -087.36358, showing turbid water entering creek.

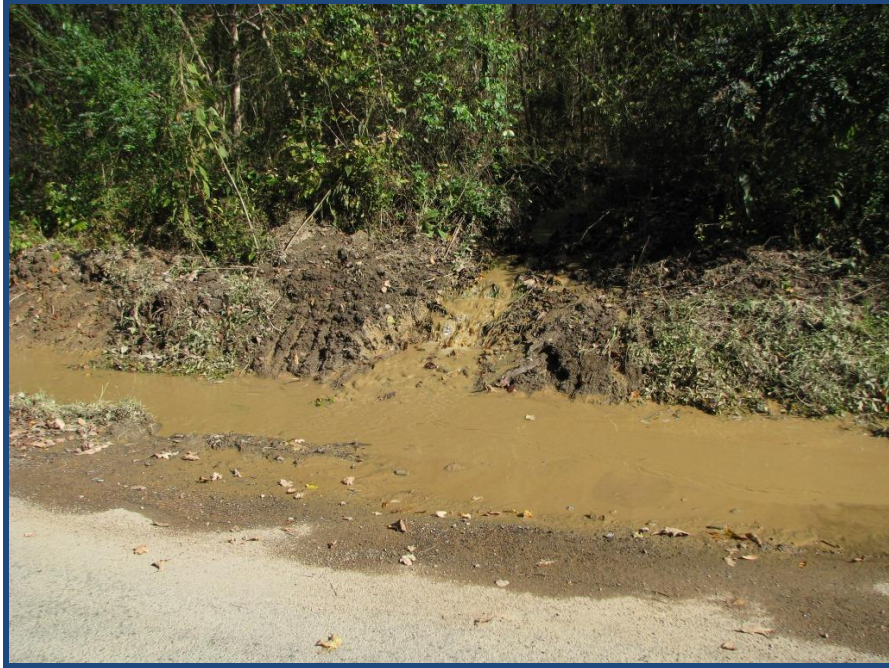
Photo 5      Site: North Fork Mill Creek      Date: October 21, 2014  
Time: 1424 hrs      Direction: Southeast      Personnel: John Hoffelt, TDOR; Candice Teichert, US EPA  
Description: Discharge from Unnamed Tributary at location 35.89628 - 087.36337, on west side of Oak Hill Road, upstream end of culvert leading to North Fork Mill Creek.

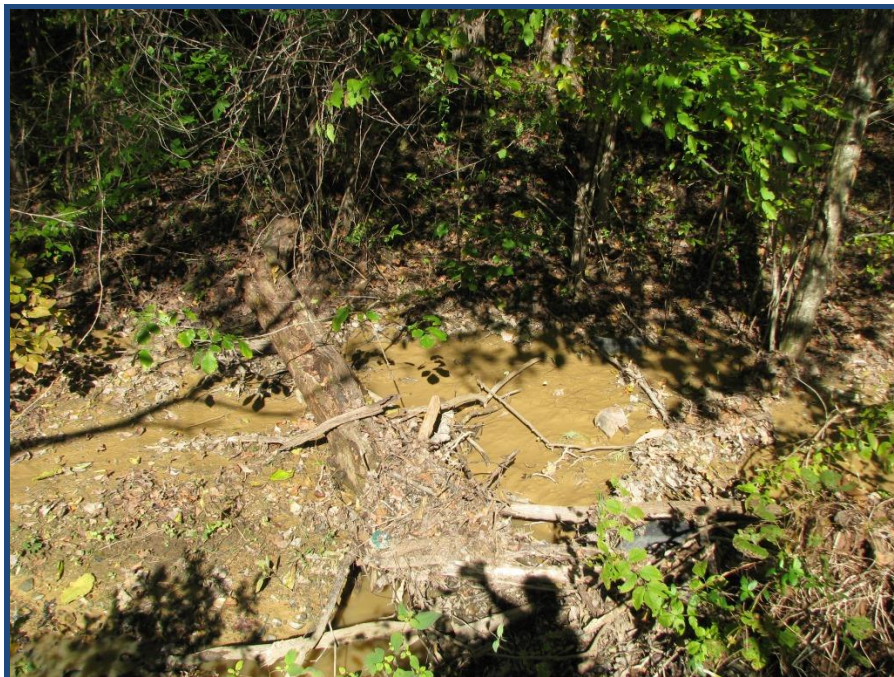
Photo 6      Site: North Fork Mill Creek      Date: October 21, 2014

Time: 1429 hrs      Direction: North      Personnel: John Hoffelt, TDOR; Candice Teichert, US EPA  
Description: Turbid water (bottom part) and mud flow deposit (top part) in Unnamed Tributary to North Fork Mill Creek at location 35.89499 -087.36067.

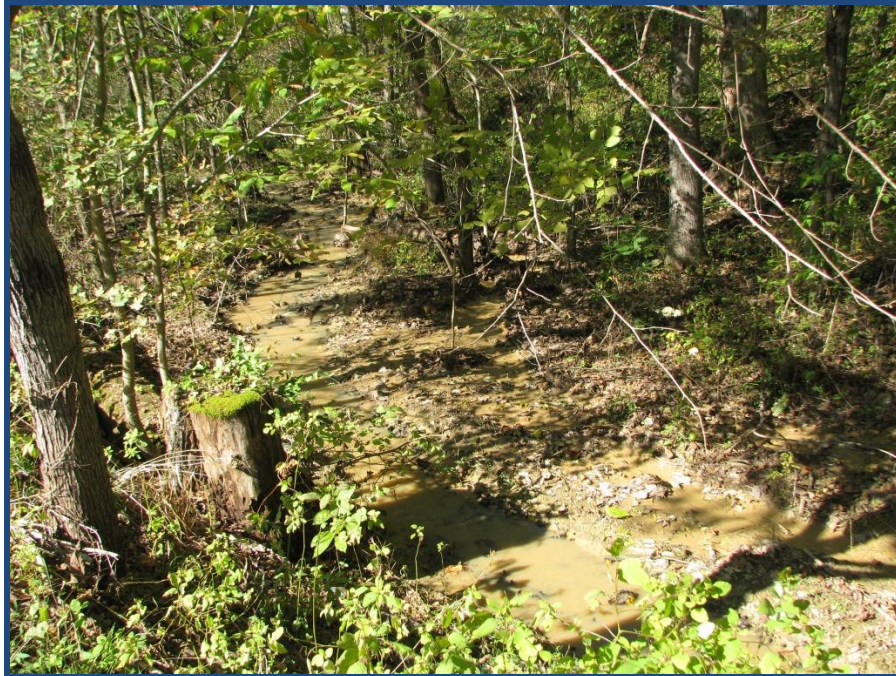
Photo 7      Site: North Fork Mill Creek      Date: October 21, 2014  
Time: 1429 hrs      Direction: Northwest      Personnel: John Hoffelt, TDOR; Candice Teichert, US EPA  
Description: Turbid water and mud flow deposits in Unnamed Tributary to North Fork Mill Creek at location 35.89468 -087.35908.

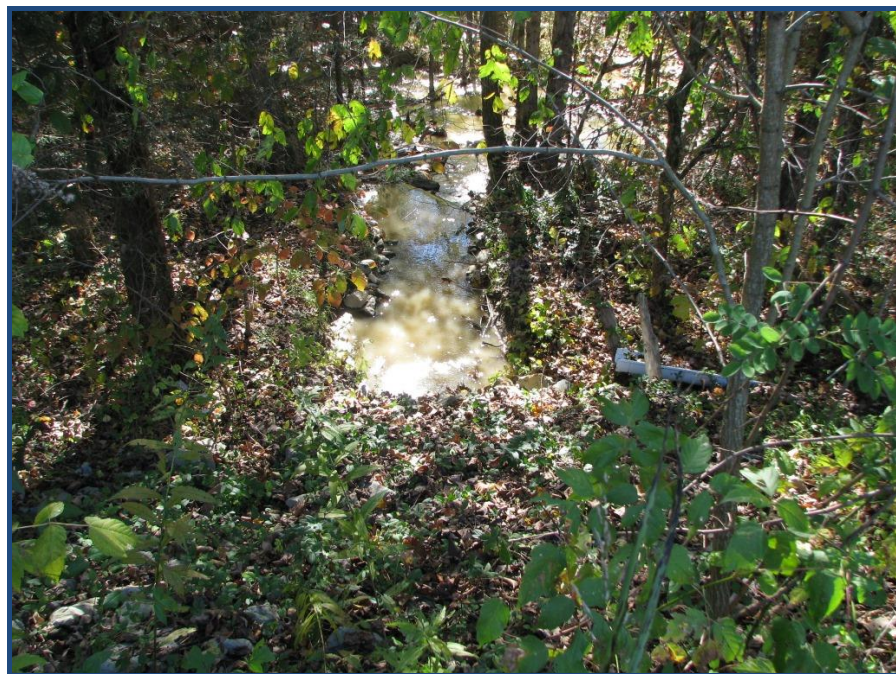
Photo 8      Site: North Fork Mill Creek      Date: October 21, 2014

Time: 1434 hrs      Direction: Southwest      Personnel: John Hoffelt, TDOR; Candice Teichert, US EPA  
Description: Turbid water discharge from Bon Aqua-Lyles Utility District outfall into Unnamed Tributary to North Fork Mill Creek at location 35.89714 -087.35708.

After meeting with the residents about their concerns, Ms. Teichert and I followed the turbid discharge to its source of origin and photo-documented the stream conditions. We found that the source was not the clear-cut operation, but rather the source was "Filter Backwash and Sedimentation Tank Wastewater" from the Bon Aqua-Lyles Utility District. The discharge outfall is marked with a sign identifying the National Pollutant Discharge Elimination System (NPDES) permit No. TN0059951.

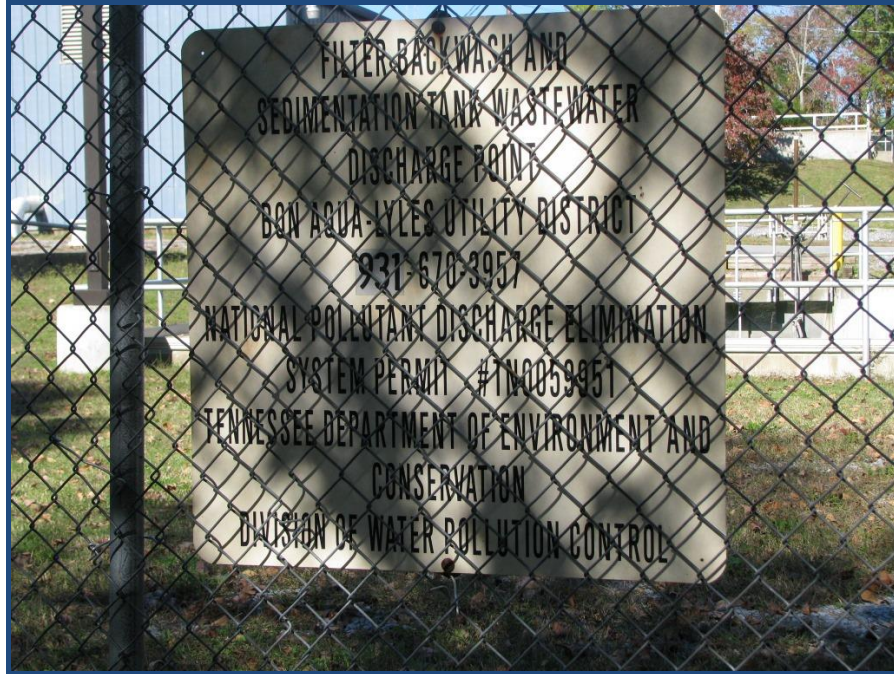
Photo 9      Site: North Fork Mill Creek      Date: October 21, 2014  
Time: 1435 hrs      Direction: Northeast      Personnel: John Hoffelt, TDOR; Candice Teichert, US EPA  
Description: NPDES outfall identification sign at Bon Aqua-Lyles Utility District outfall into Unnamed Tributary to North Fork Mill Creek at location 35.89714 -087.35708.
